# TN-USB-FX-01 Manual Update

## Driver Installation Note - Change “Speed and Duplex” to “100 Mbps Full Duplex”

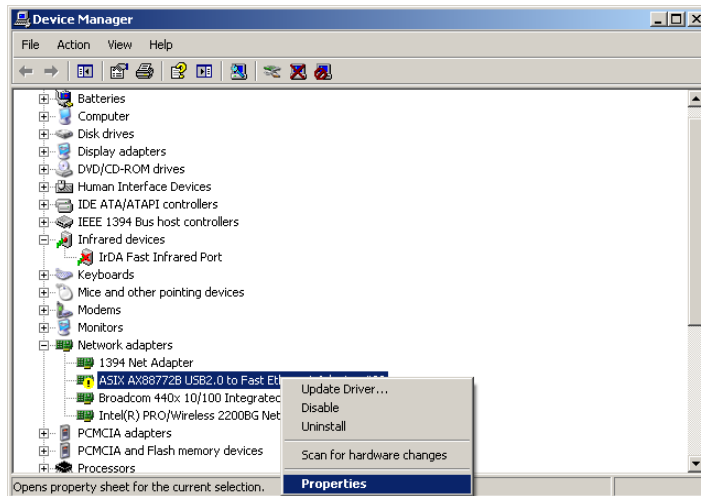
1. In Windows, navigate to the Start > Settings > Control Panel > System > Device Manager > Network Adapters menu path.

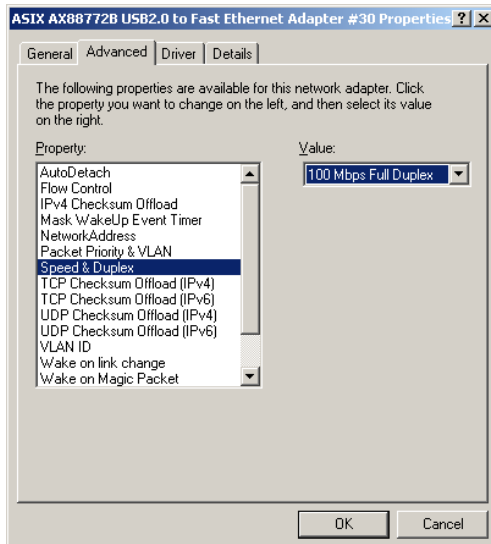
2. Select and right click the “ASIX AX88772B USB to Fast Ethernet Adapter” (the name of the chipset / manufacturer). The General tab displays the message “Windows has stopped this device because it has reported problems.(Code 43)”.
3. Select “Properties” and then select the “Advanced” tab.

4. At the “Speed and Duplex Property Value” dropdown, change the Ethernet link speed from “Auto Negotiation” to “100 Mbps Full Duplex”.
5. Click the **OK** button.
6. Unplug and replug the TN-USB-FX-01. The device will now run properly.
